# **CERTIFICATION REPORT**

## **Settling Pond Sediment Removal and Improvements**

**LOCKWOOD ASH DISPOSAL SITE**

**December 2019**

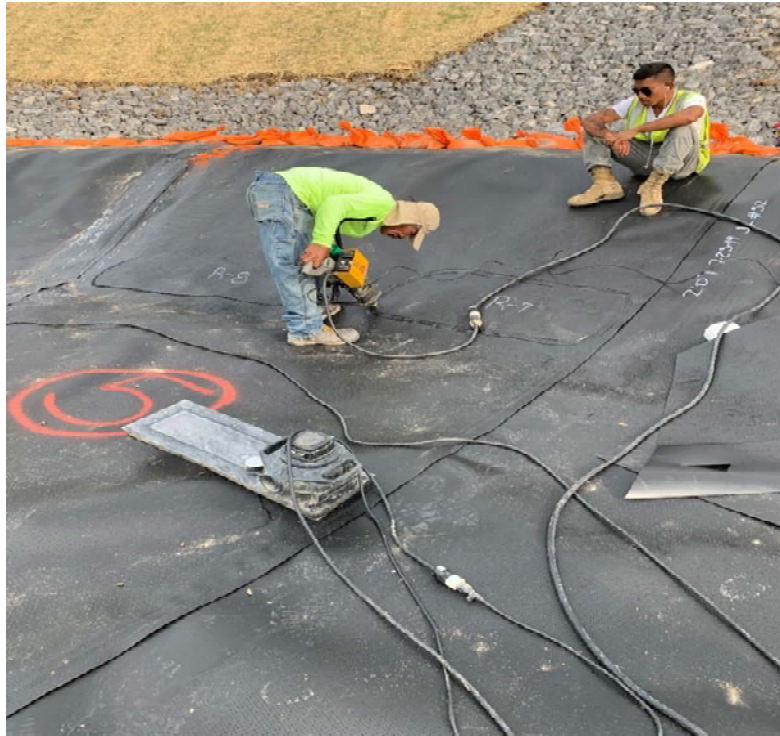
Photo 24- Geomembrane Non-Destructive Seam Air Pressure Testing
