May 31, 2019

**Re: Lockwood Hills LLC Consent Order Case No. R8-20140710-47  
Investigation of Solids Scouring during Leachate Pond Discharge Events**

**DAIGLER ENGINEERING, PC**

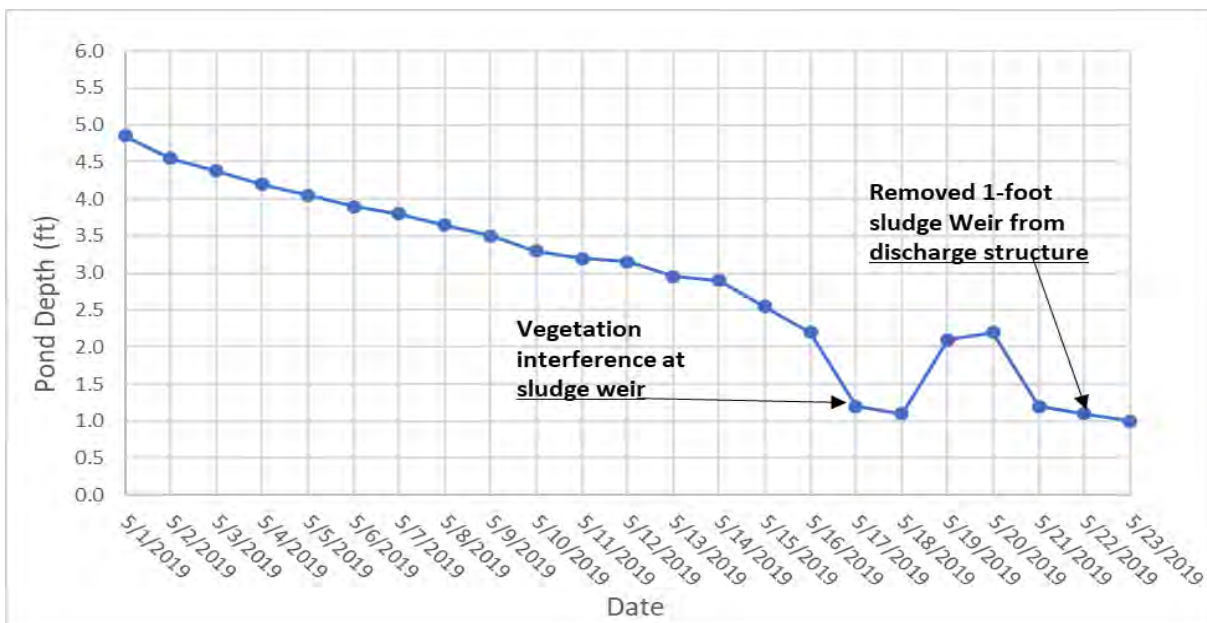
**FIGURE 1: MEASURED POND DEPTH**

Figure 1 shows the depth in the Pond fell steadily between May 1<sup>st</sup> and May 16<sup>th</sup>. On May 17<sup>th</sup> and 18<sup>th</sup> the staff gauge readings were artificially low. The staff gauge is mounted in the chute of the discharge structure downstream of the sludge weir and upstream of the 4-inch discharge pipe (See Sampling Location figure in Attachment 1). Vegetation was getting hung up on the one-

foot sludge weir and pushed over in slugs by the rising water level behind it. The chute in the area of the staff gauge would empty out between the slugs of liquid causing the artificially low depth measurements. By May 19<sup>th</sup>, most loose vegetation in the Pond had already been flushed out and vegetation interference was no longer notable.

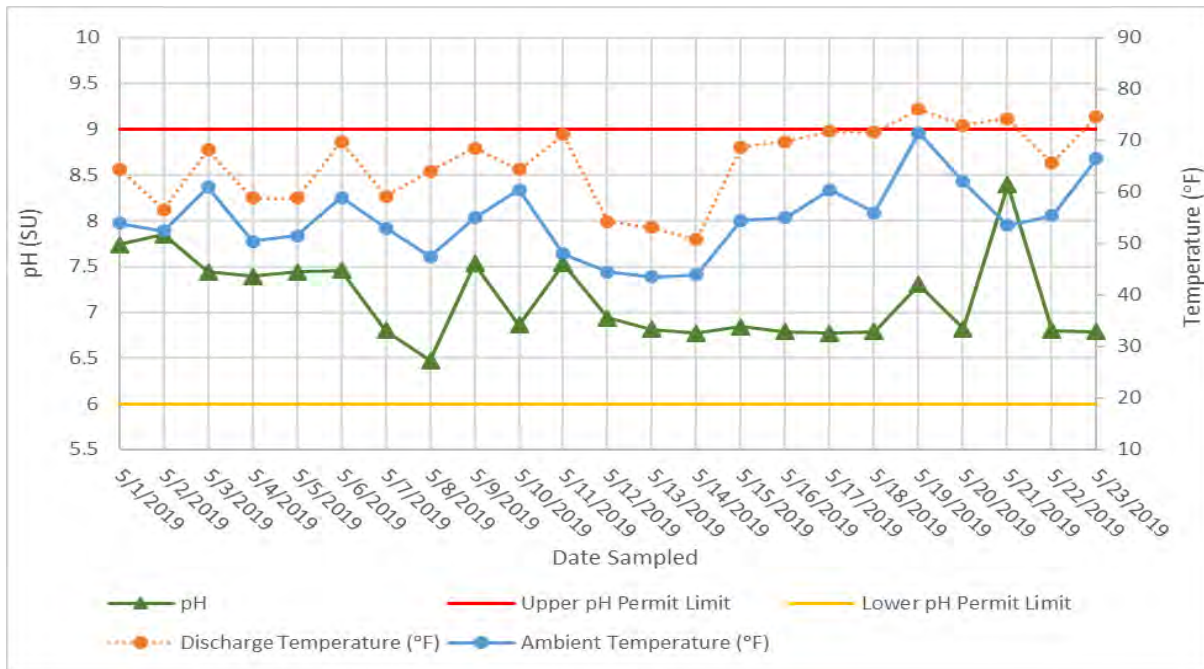
**FIGURE 2: TEMPERATURE AND pH FIELD TESTING RESULTS**

As detailed in Figure 2, the temperature of the discharge ranged between 51°F and 76°F with an average value of 66°F. The temperatures of the Pond discharge are reflective of ambient temperature over the course of the discharge event. The pH of the discharge ranged between 6.47 and 8.39 with an average value of 7.14 SU. The range of pH measured remained comfortably between the maximum and minimum effluent limits (6.0 to 9.0 SU) stipulated in Lockwood’s SPDES permit throughout the entire event with no observable trending.

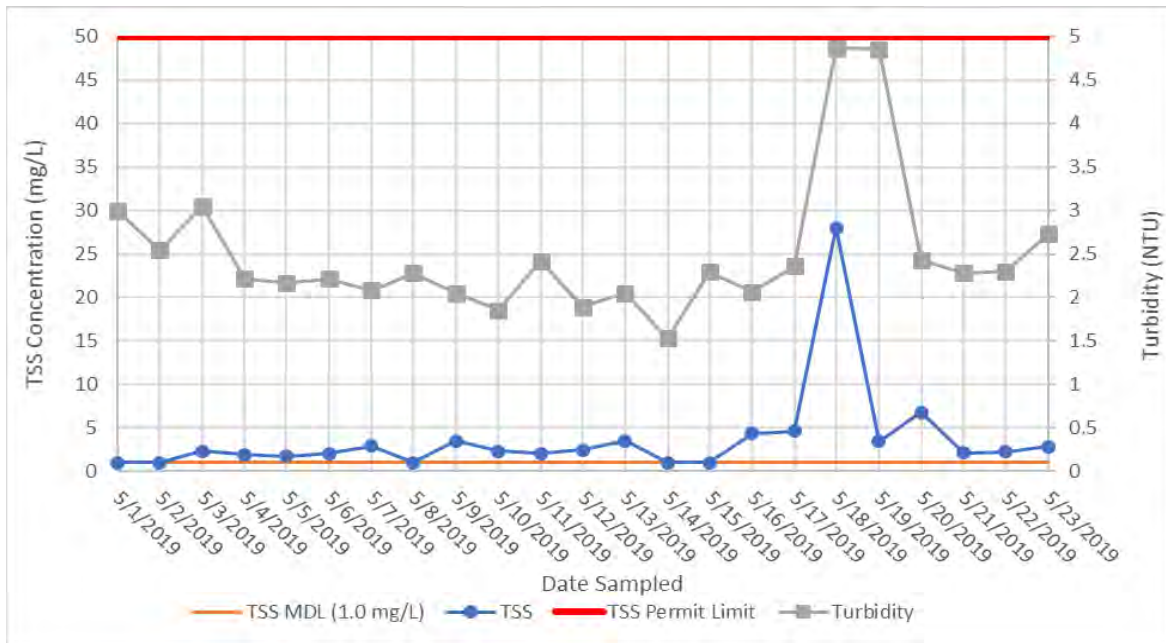
**FIGURE 3: LABORATORY TSS AND FIELD TURBIDITY TESTING RESULTS**

The results of turbidity field testing and laboratory TSS analysis are provided in Figure 3. Turbidity values ranged between 1.53 Nephelometric Turbidity Units (NTU) and 4.87 NTU with an average value of 2.50 NTU. There is no permit limitation on turbidity. TSS concentrations ranged from the minimum being less than detection (< 1 mg/L) to the maximum TSS of 28 mg/L with an average value of 4.2 mg/L.

As shown in Figure 3, TSS remained less than an order of magnitude lower than the Lockwood SPDES permit compliance limit of 50 mg/L throughout the majority of the event with no observable trending. Photographs taken of the discharge grab samples and the samplers field observation notes confirm that there is no discernable difference in the water quality of the discharge between the beginning and end of the event. The notable TSS reading of 28.0 mg/L on May 18<sup>th</sup> and the corresponding elevated turbidity readings were a result of algae in the sample as noted on the field observation form. The algae is visible in the photo of the sample collected on that day.
