# **CERTIFICATION REPORT**

## **Settling Pond Sediment Removal and Improvements**

**LOCKWOOD ASH DISPOSAL SITE**

**December 2019**

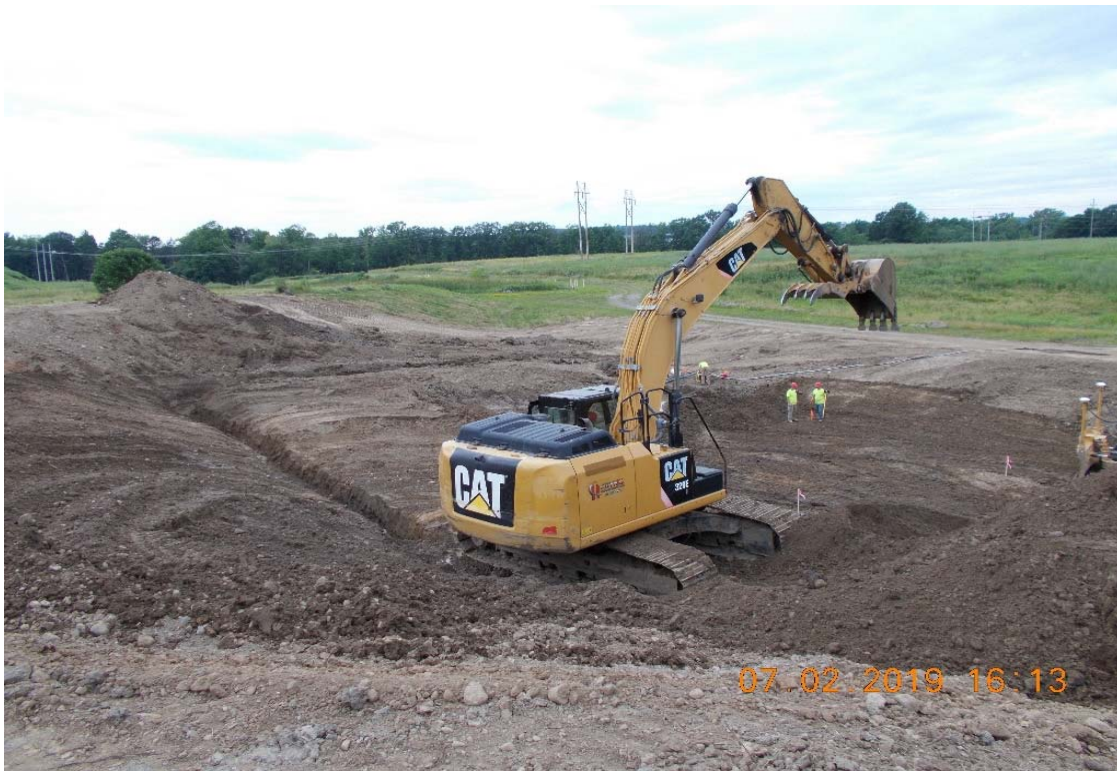
Photo 1 - LSTA Subgrade Excavation Looking Northwest

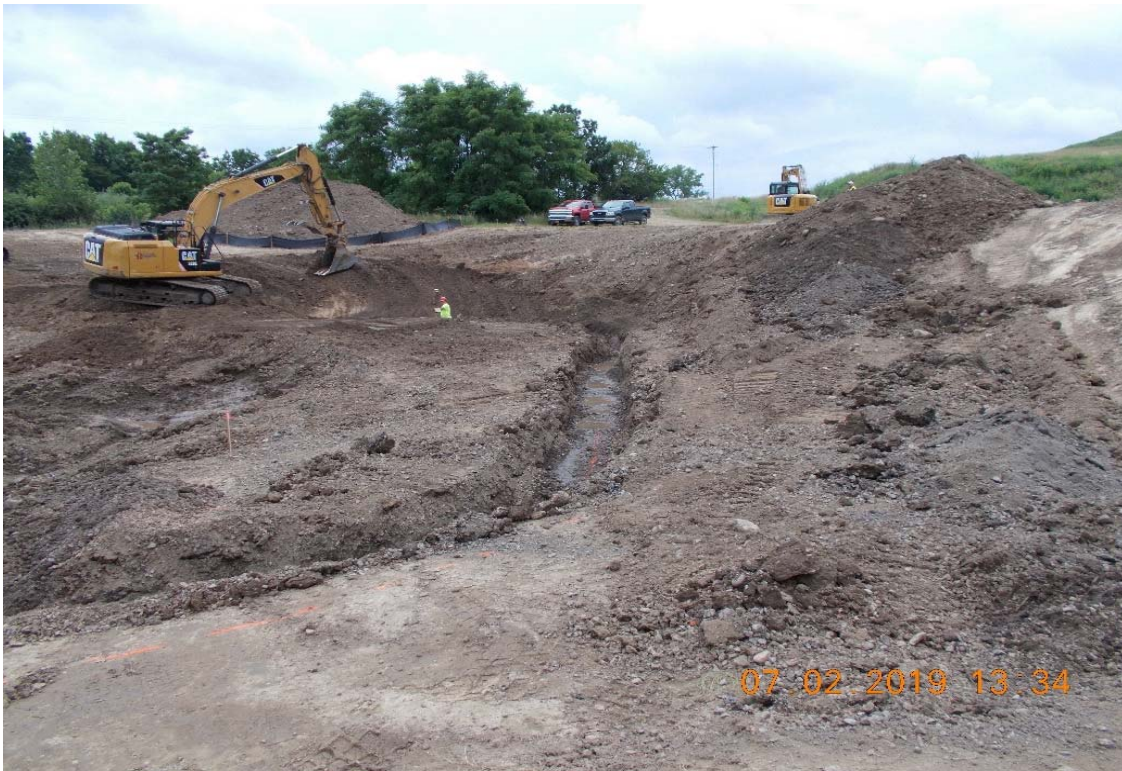
Photo 2 - LSTA Subgrade Excavation Looking East

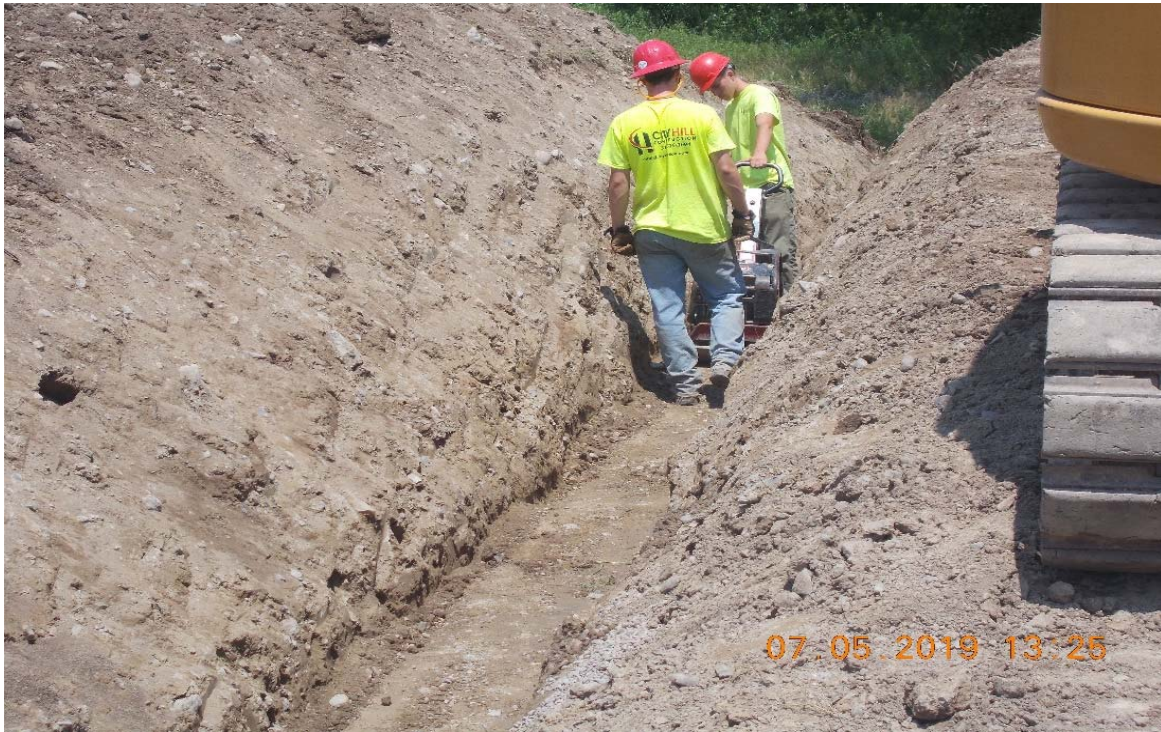
Photo 3- LSTA Porewater Discharge Pipe Trench Compaction

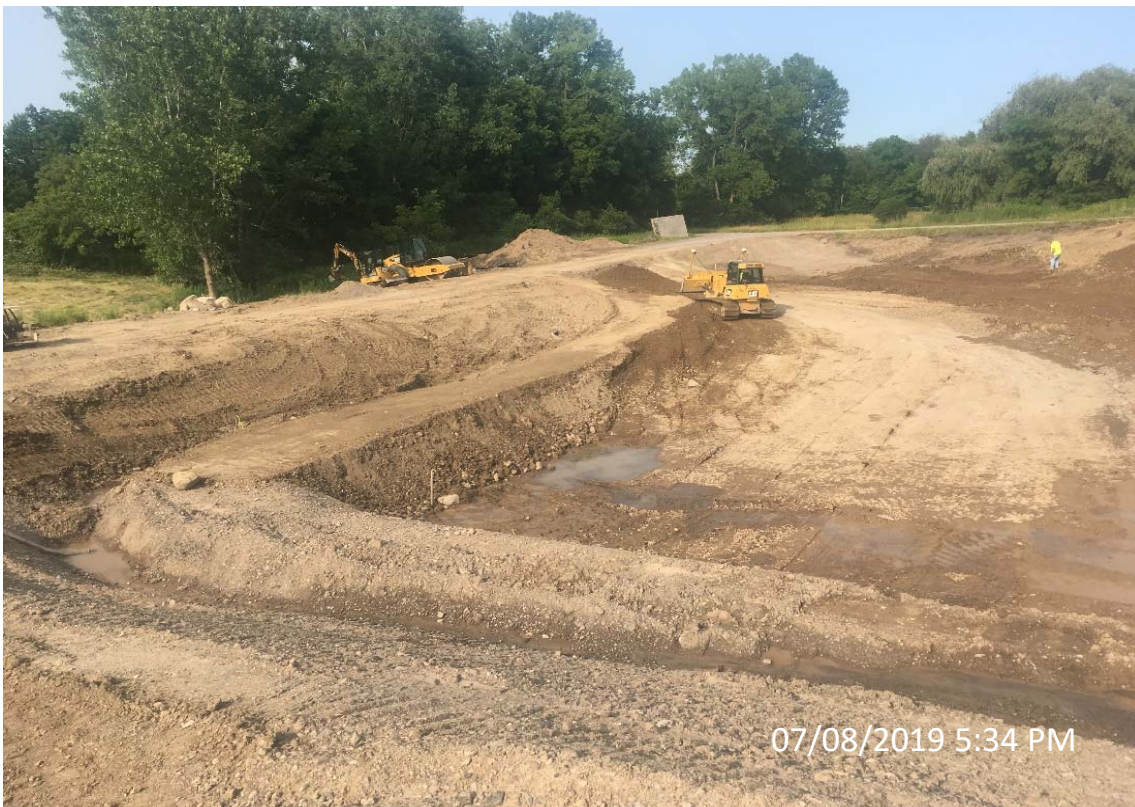
Photo 4- LSTA North and West Berm Construction Looking East

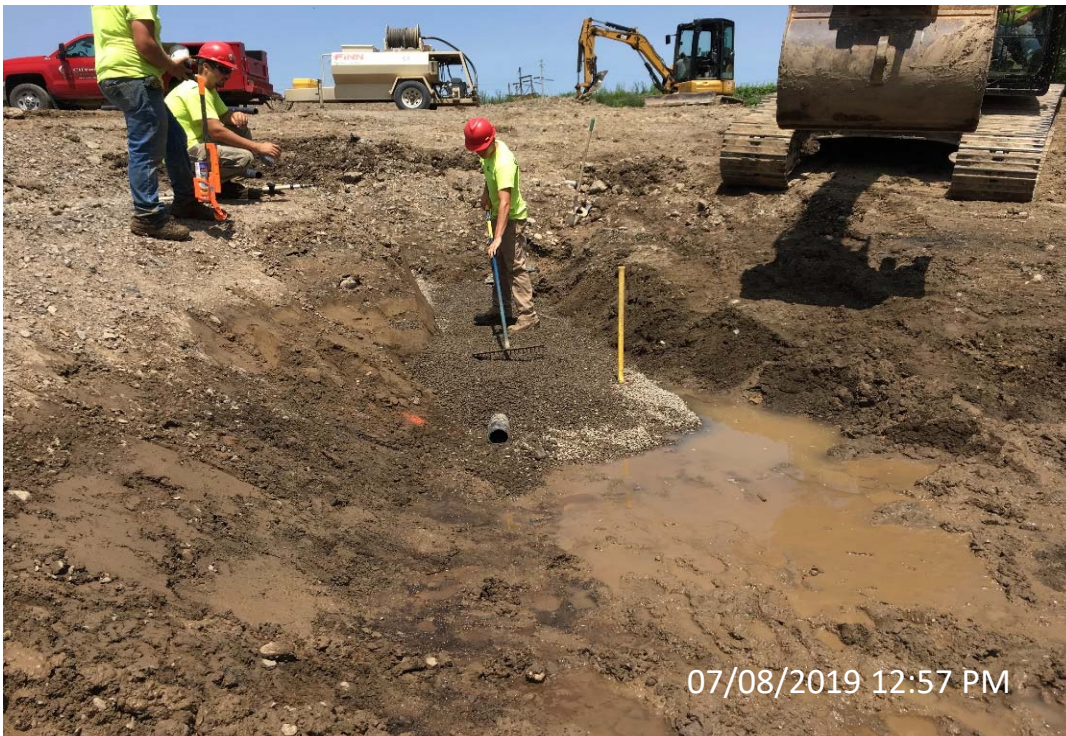
Photo 5- Porewater Discharge Pipe Installation Looking North

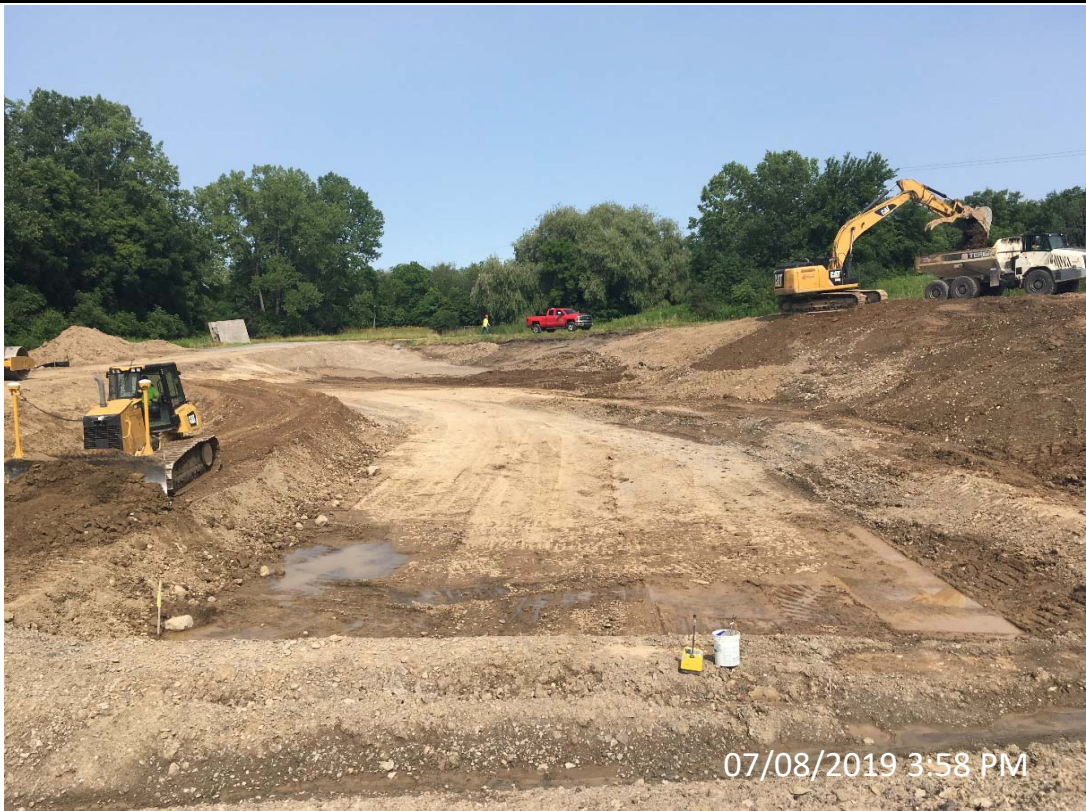
Photo 6- Nuclear Densometer Testing on the West Berm Looking East

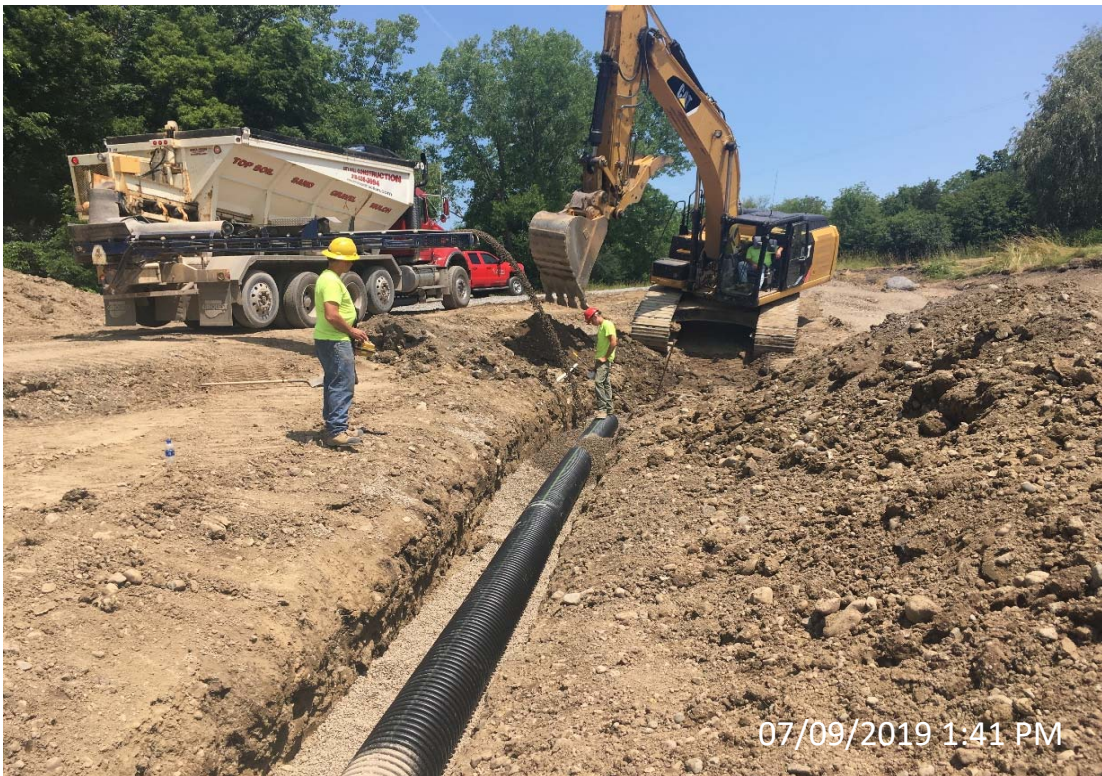
Photo 7- Northern 12- inch Culvert Installation Looking East

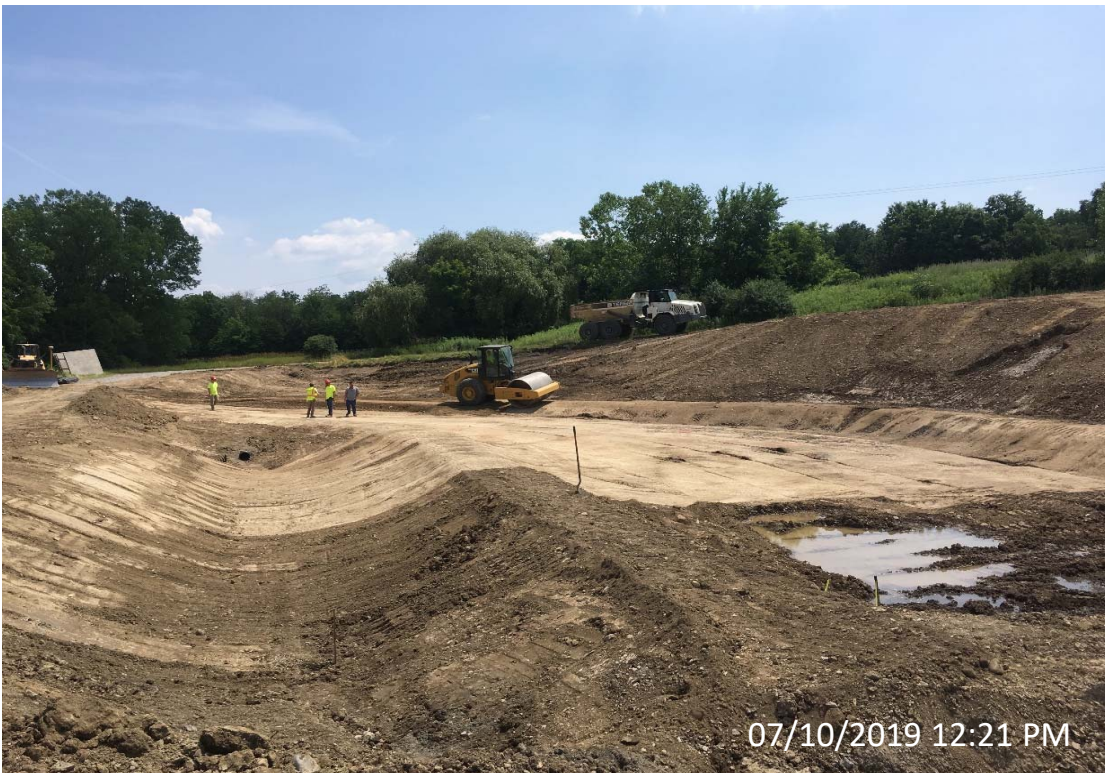
Photo 8 - LSTA Subgrade Preparation Looking East

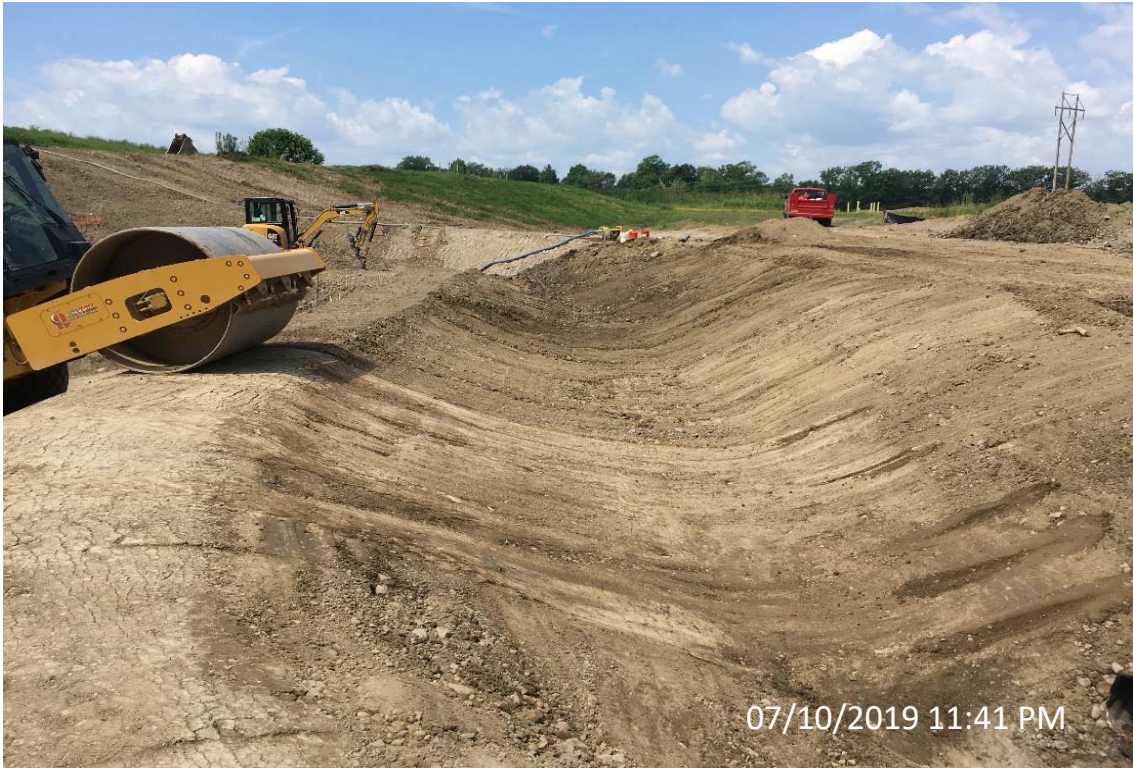
Photo 9- Compacting North Berm Looking West

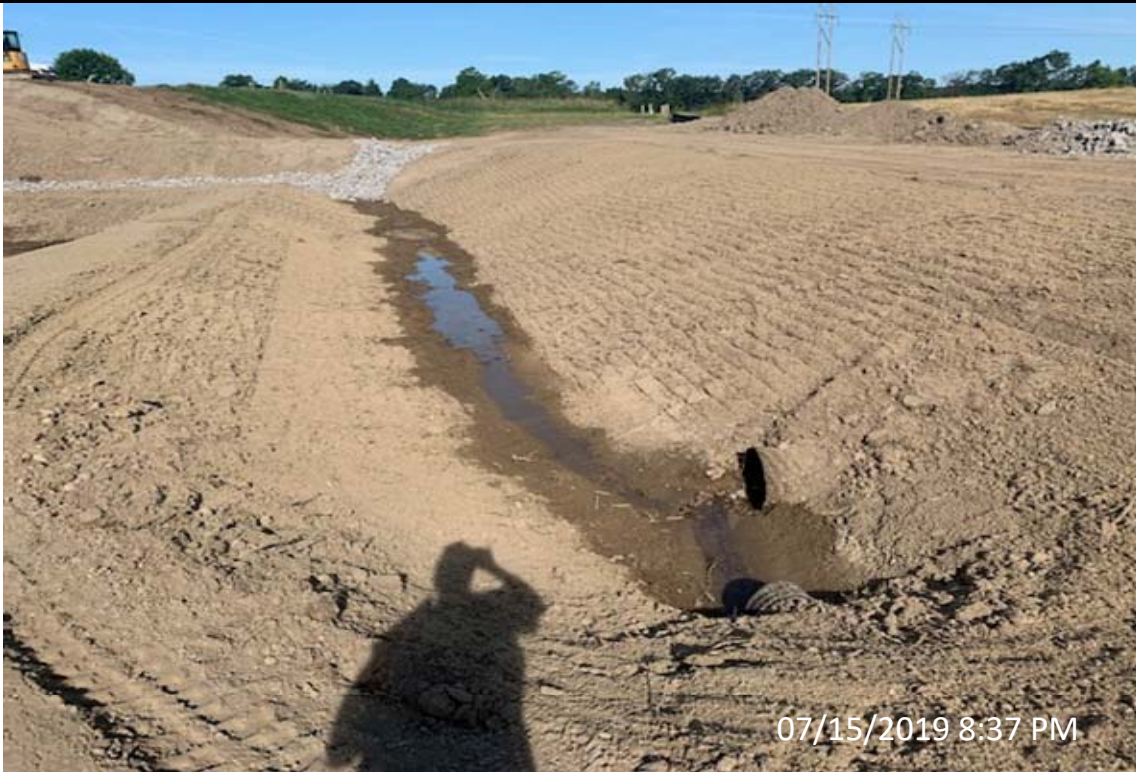
Photo 10- North Drainage Channel at Culverts Looking West

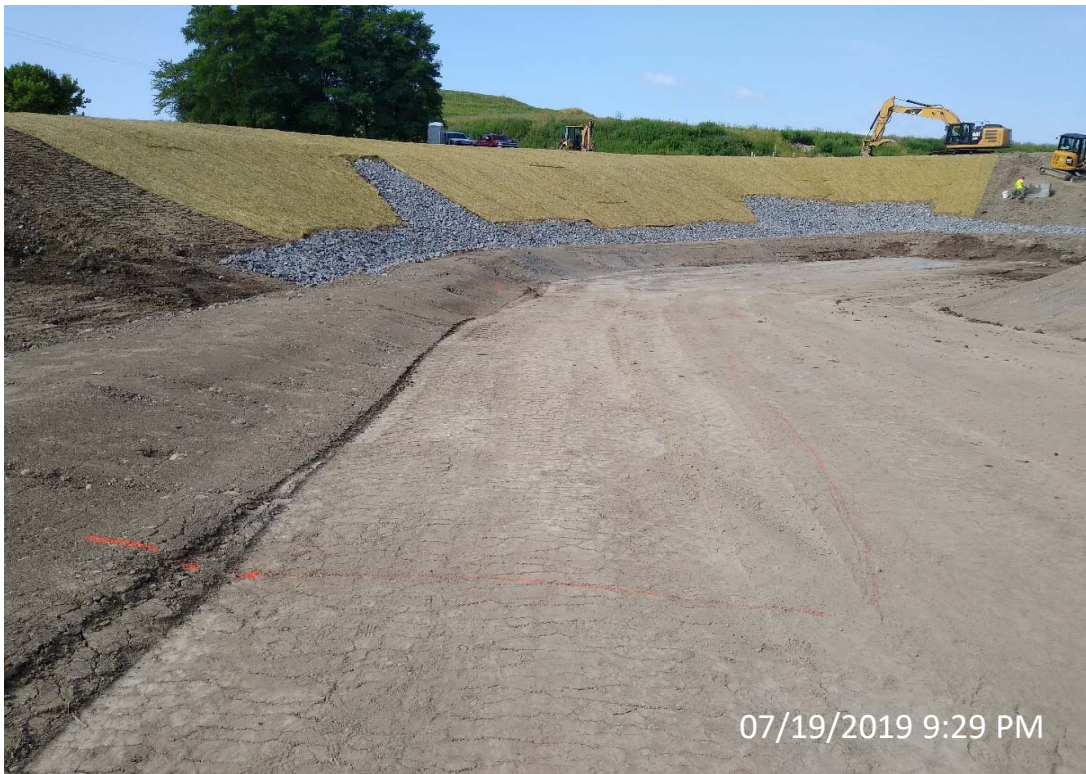
Photo 12- LSTA Subgrade Looking Southwest

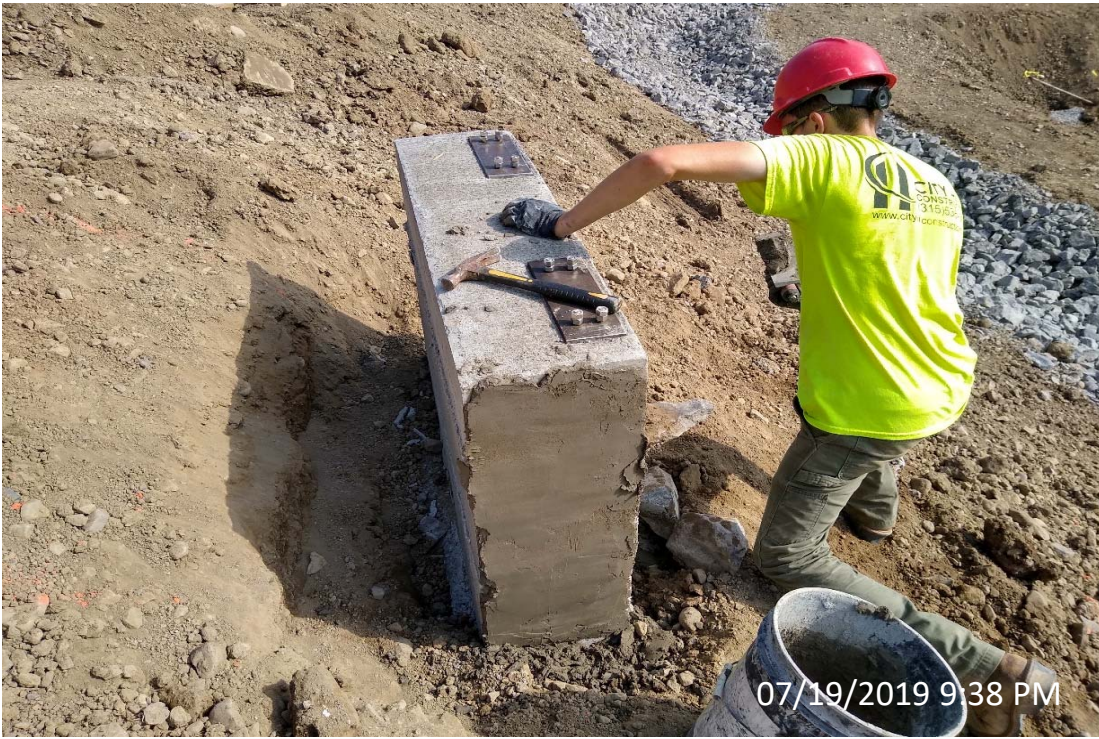
Photo 13- LSTA Pipe Bridge Concrete Footer

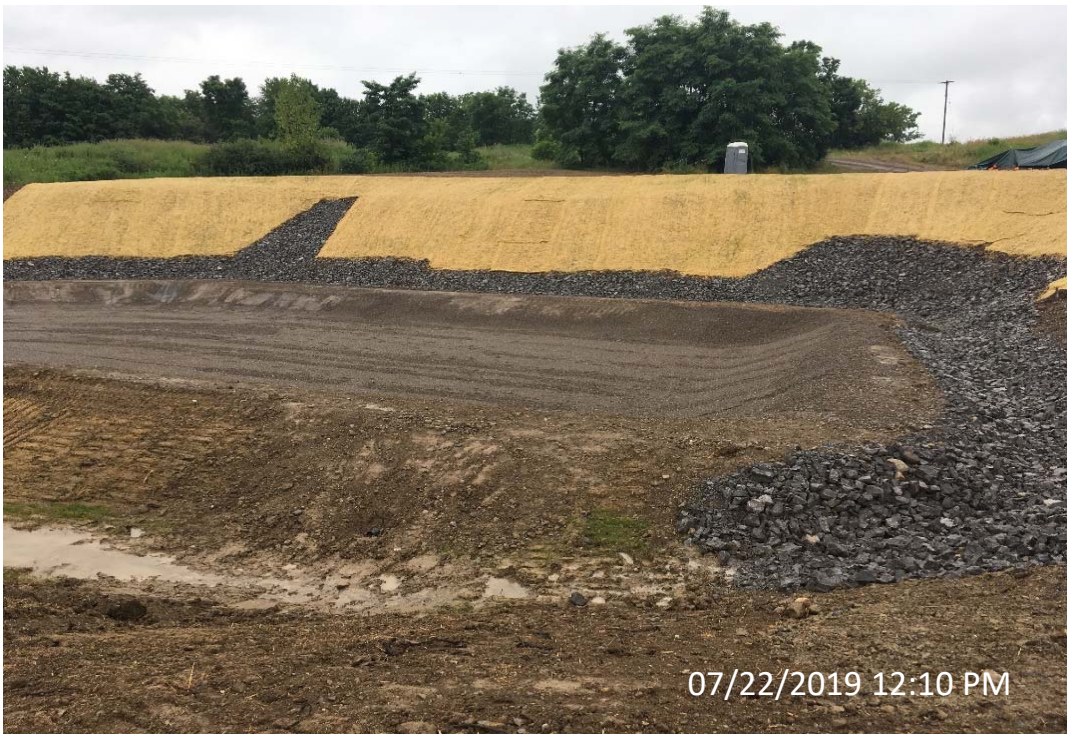
Photo 15- LSTA No. 1 Stone Subgrade Looking South

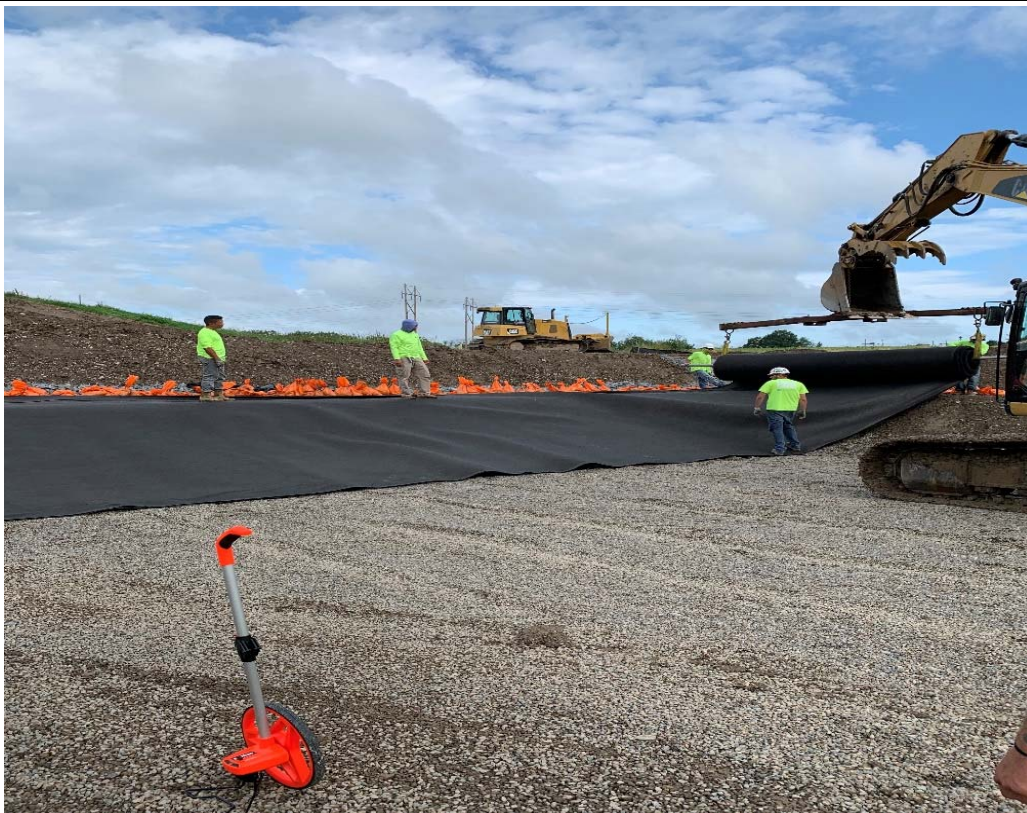
Photo 16 - LSTA Porewater Geocomposite Placement over No. 1 Stone Subgrade

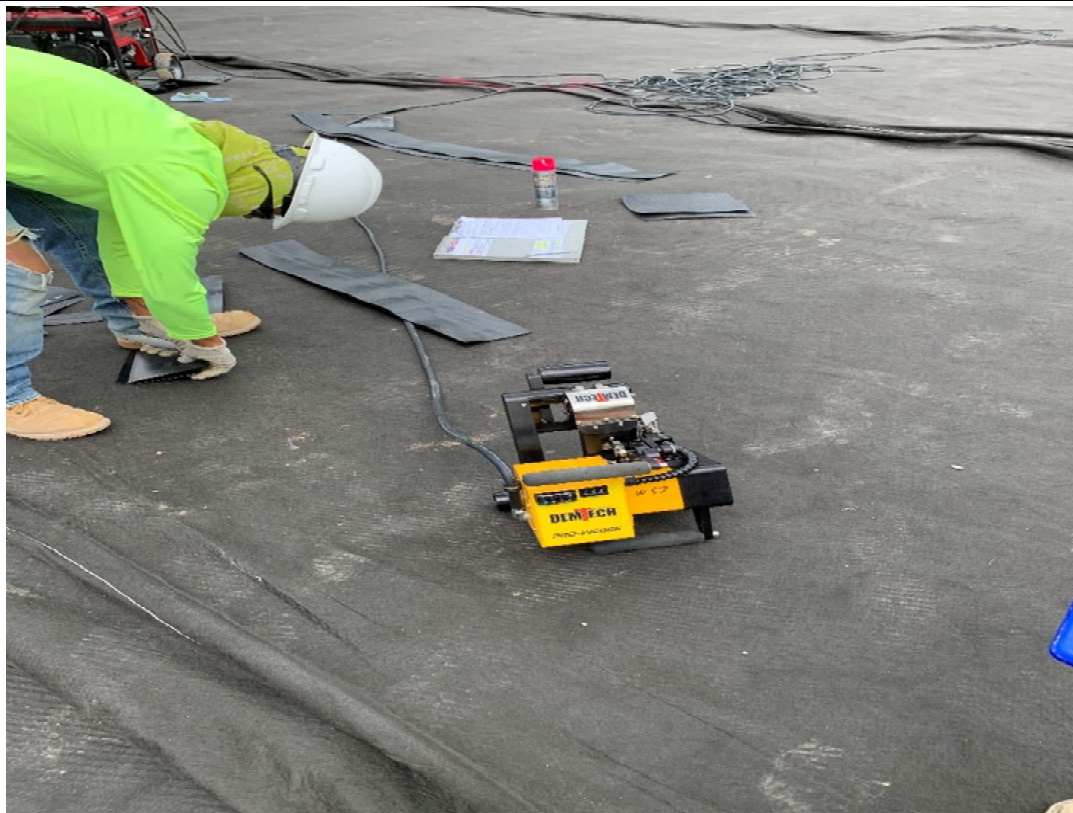
Photo 18 - LSTA Trial Weld Preparation

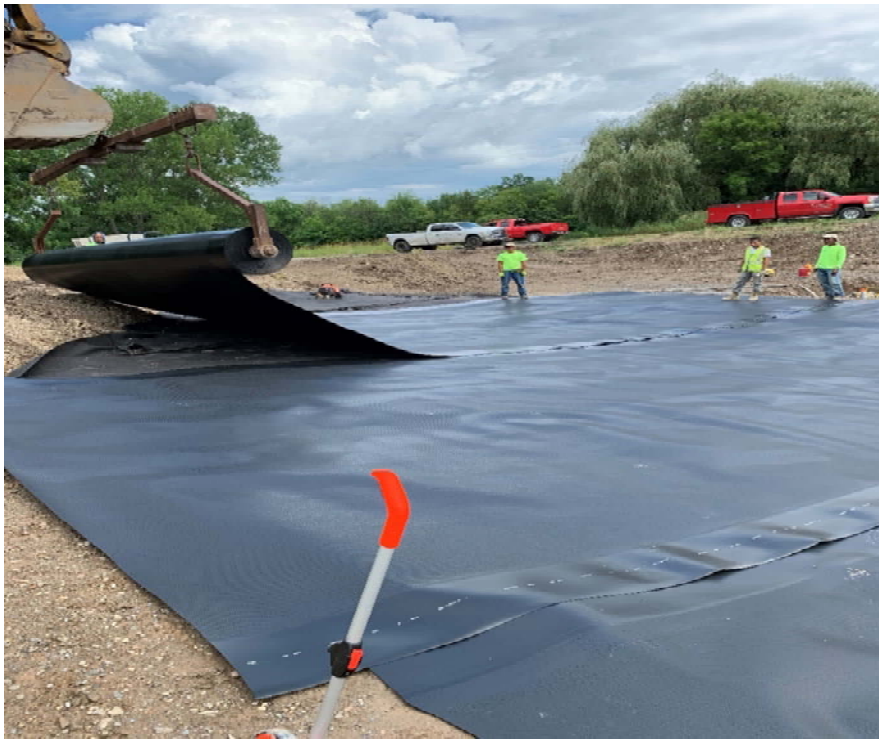
Photo 19- LSTA 60-mil HDPE Geomembrane Placement

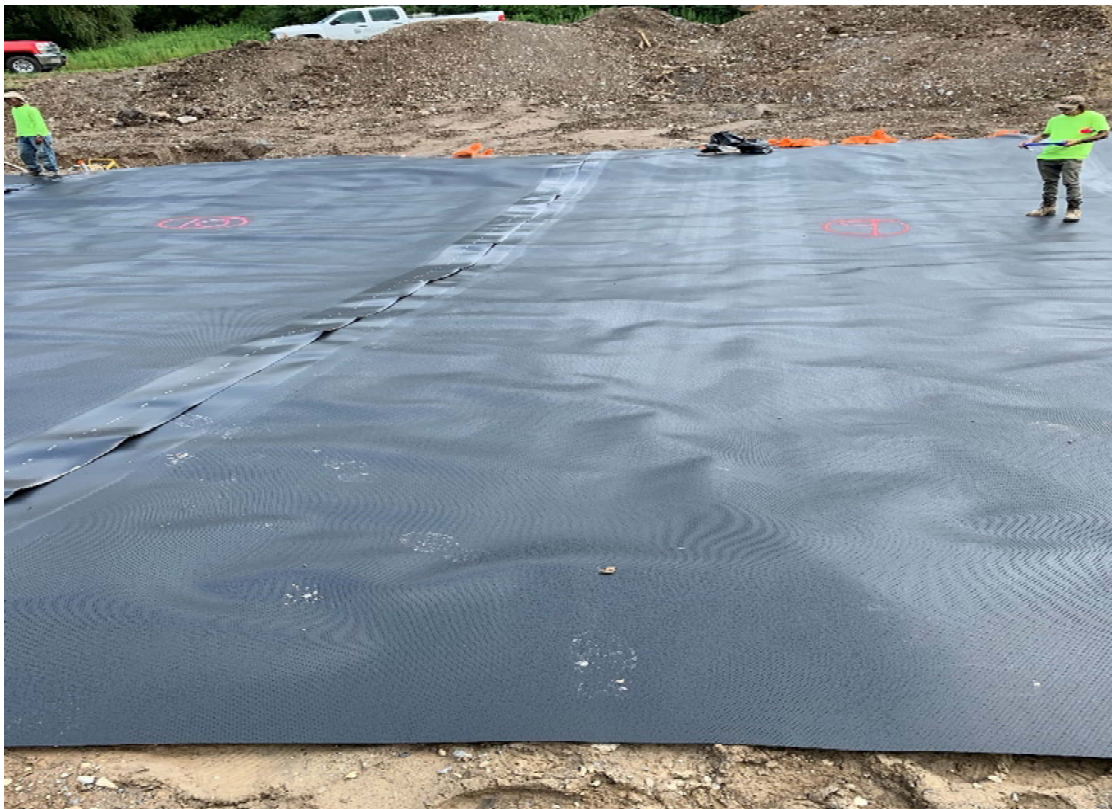
Photo 20 - LSTA 60-mil HDPE Geomembrane Installation

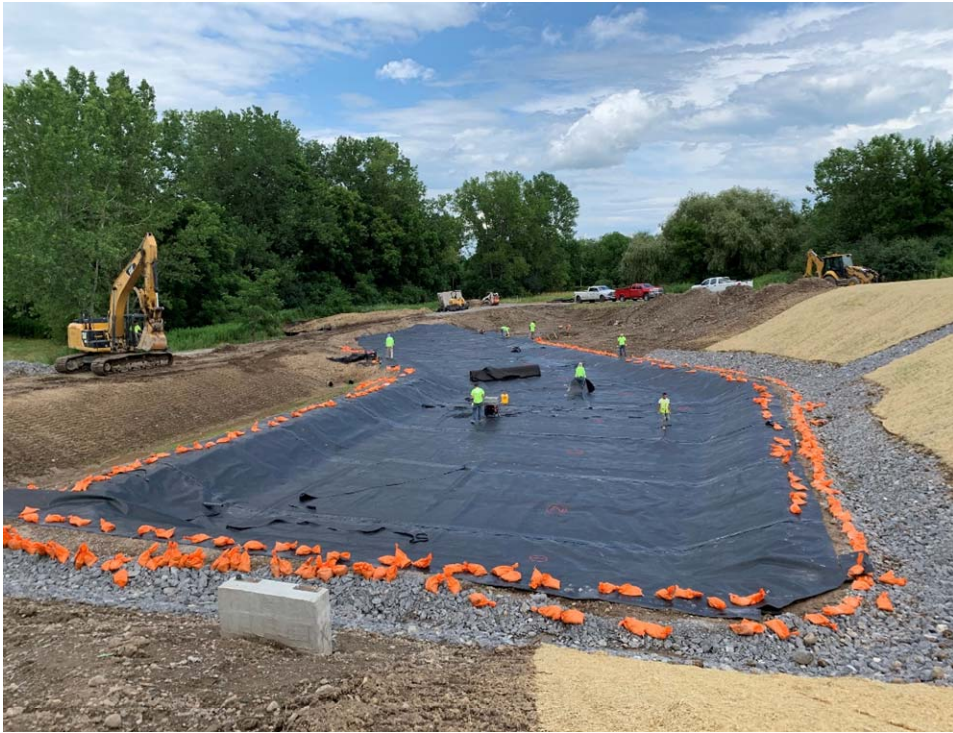
Photo 21- LSTA 60-mil HDPE Geomembrane Installation Looking East

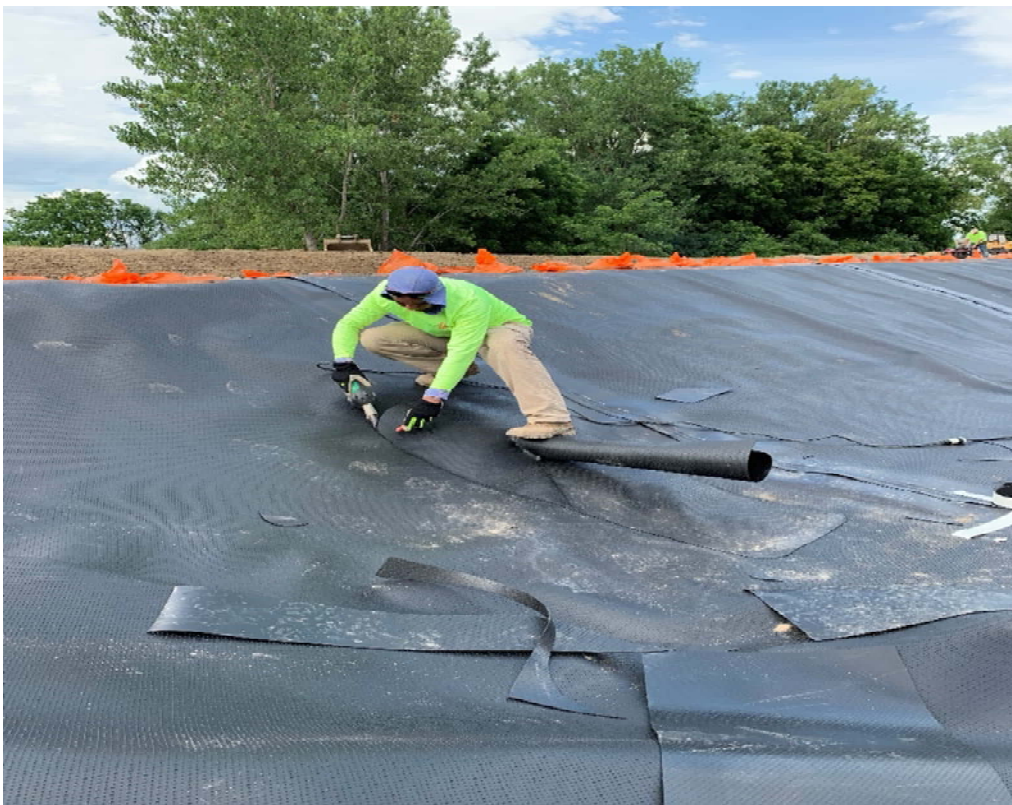
Photo 22- Geomembrane Boot Installation at LSTA Discharge Pipe

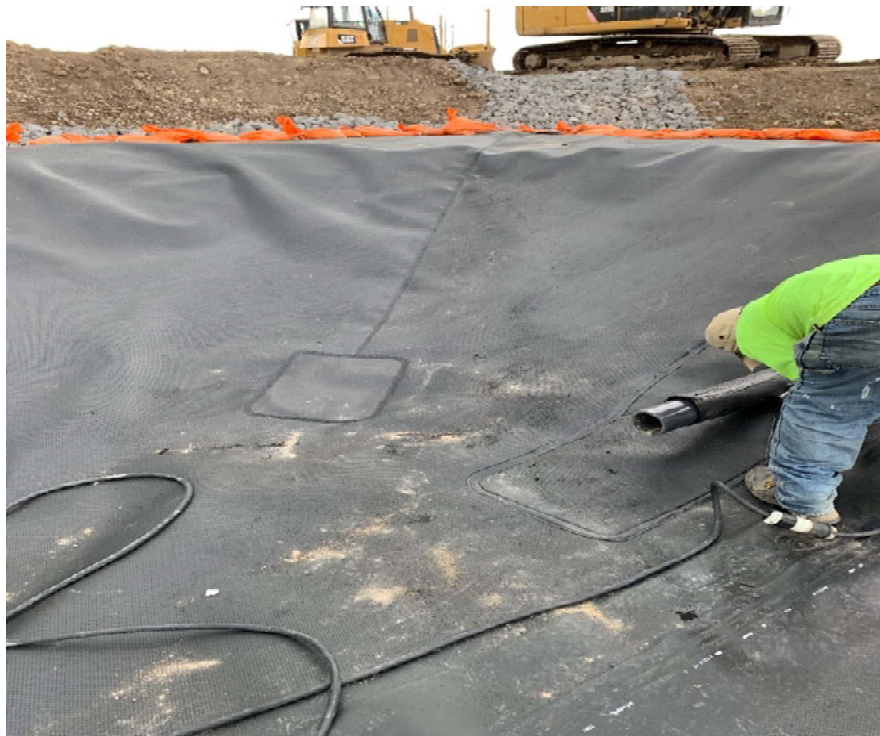
Photo 23- Geomembrane Boot Installation at LSTA Discharge Pipe

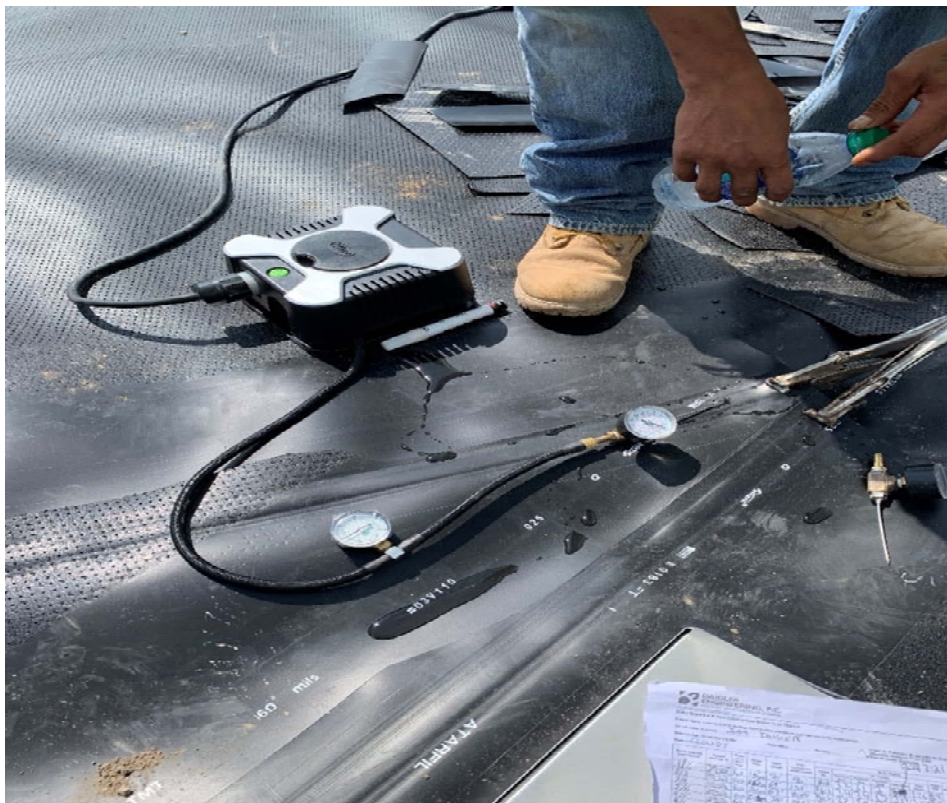
Photo 24- Geomembrane Non-Destructive Seam Air Pressure Testing

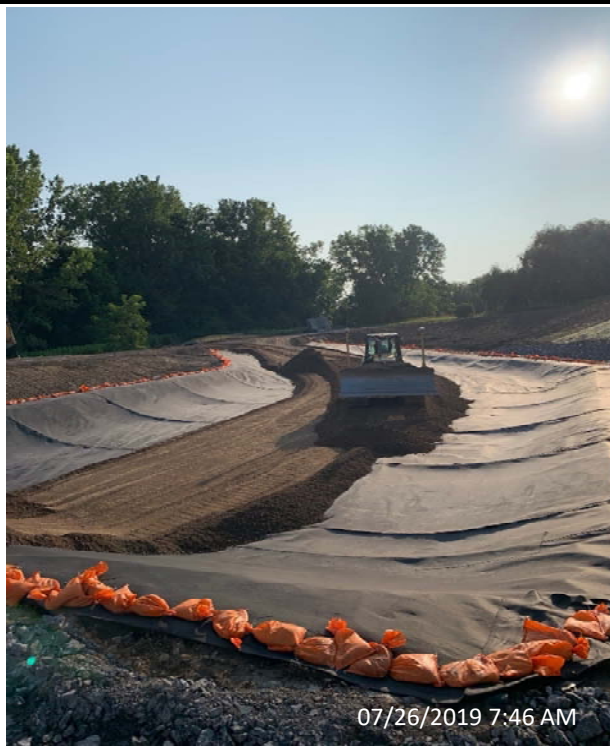
Photo 29- Placement of Type 2 Stone on the LSTA over the Cushion Geotextile

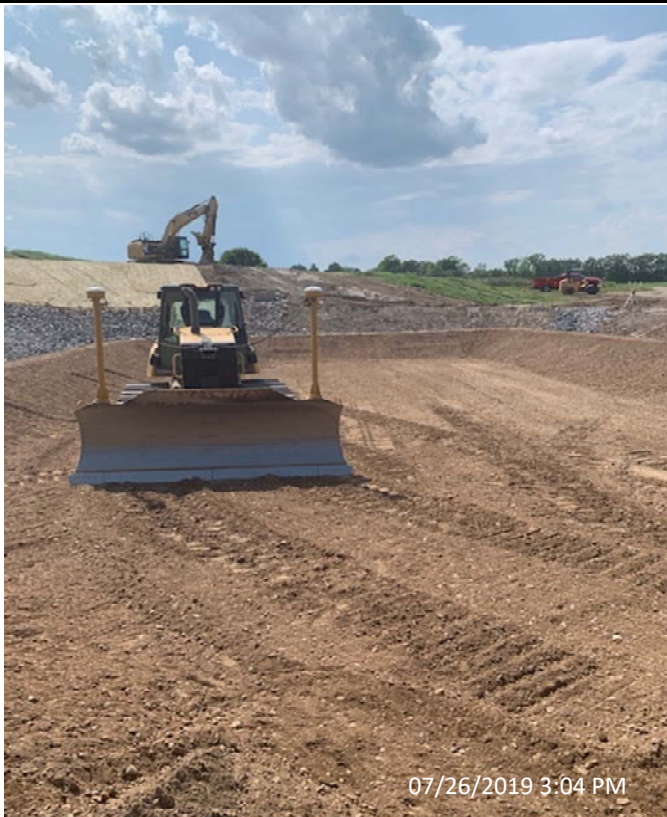
Photo 30- Grading LSTA Type 2 Stone

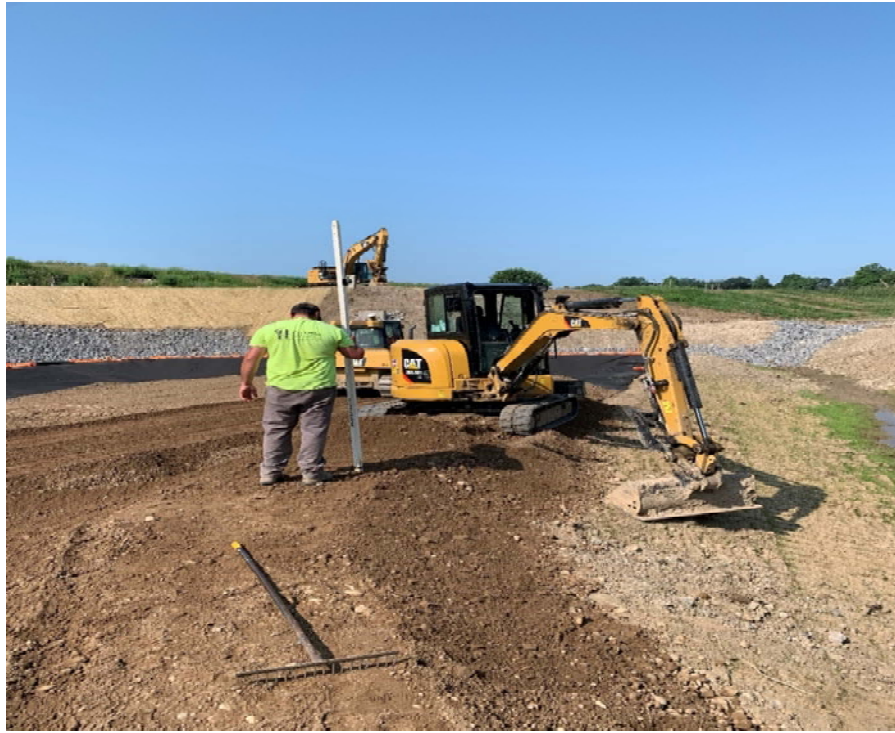
Photo 31- Checking LSTA Type 2 Stone Thickness

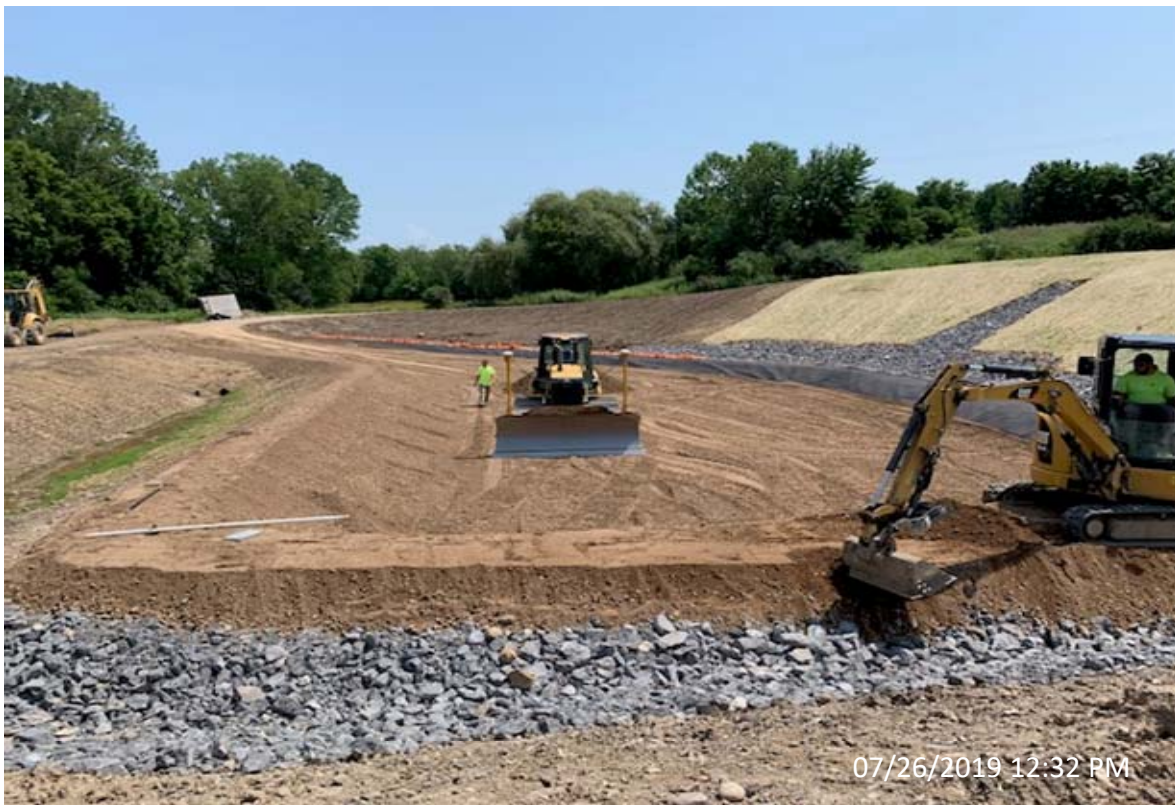
Photo 32- Grading LSTA Type 2 Stone

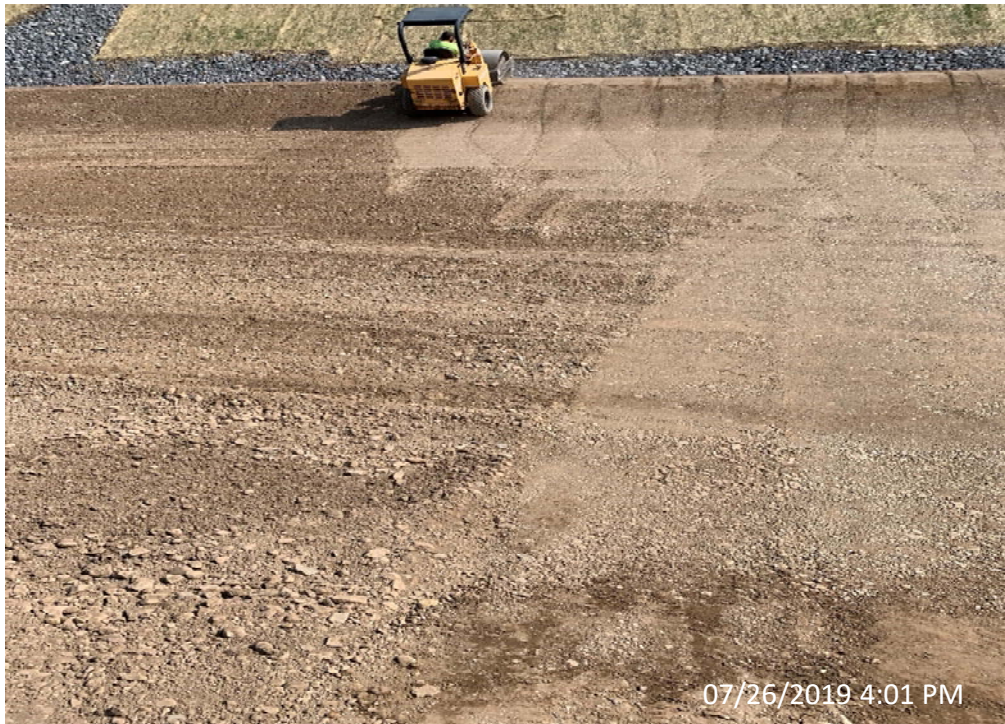
Photo 33- Compaction of LSTA Type 2 Stone Looking South

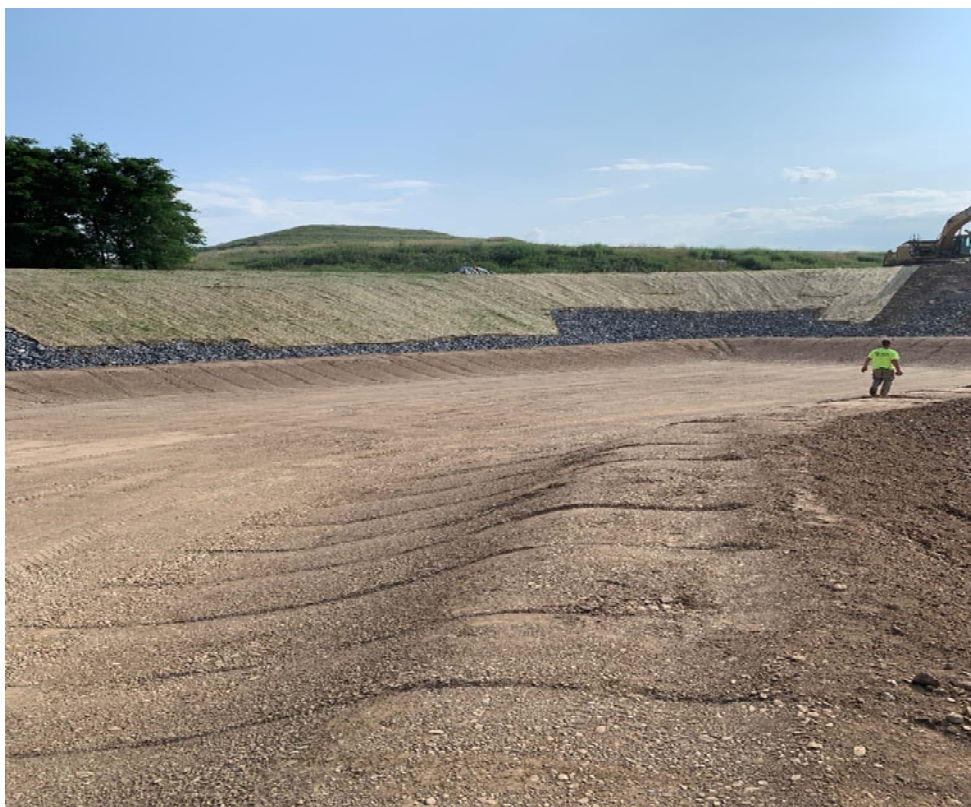
Photo 34 - LSTA Compacted Type 2 Stone Looking Southwest

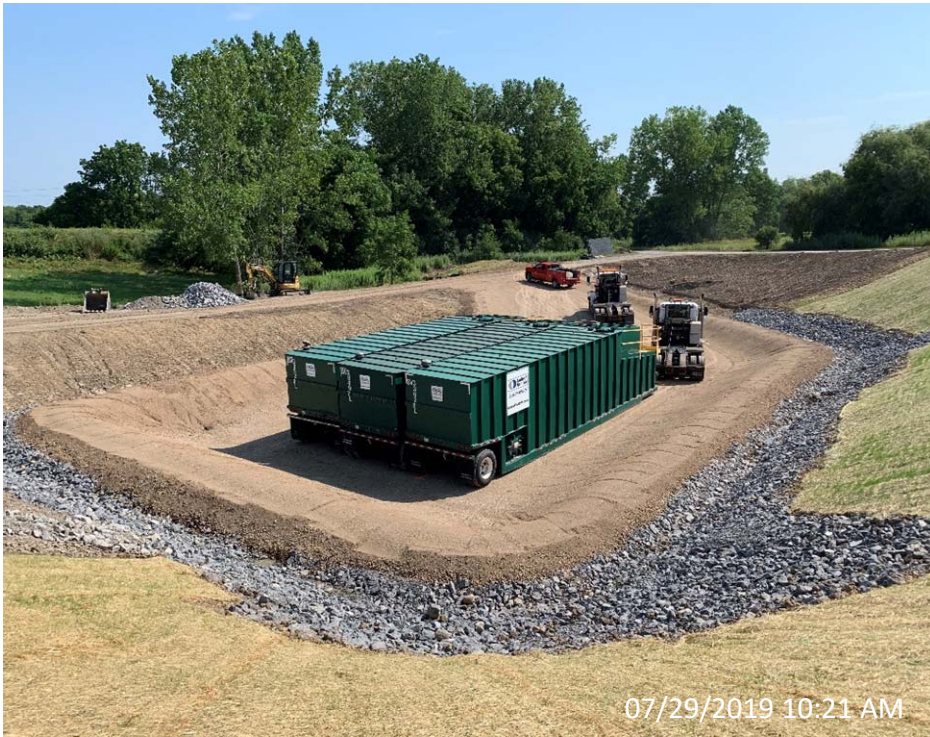
Photo 35- LSTA Storage Tank Placement

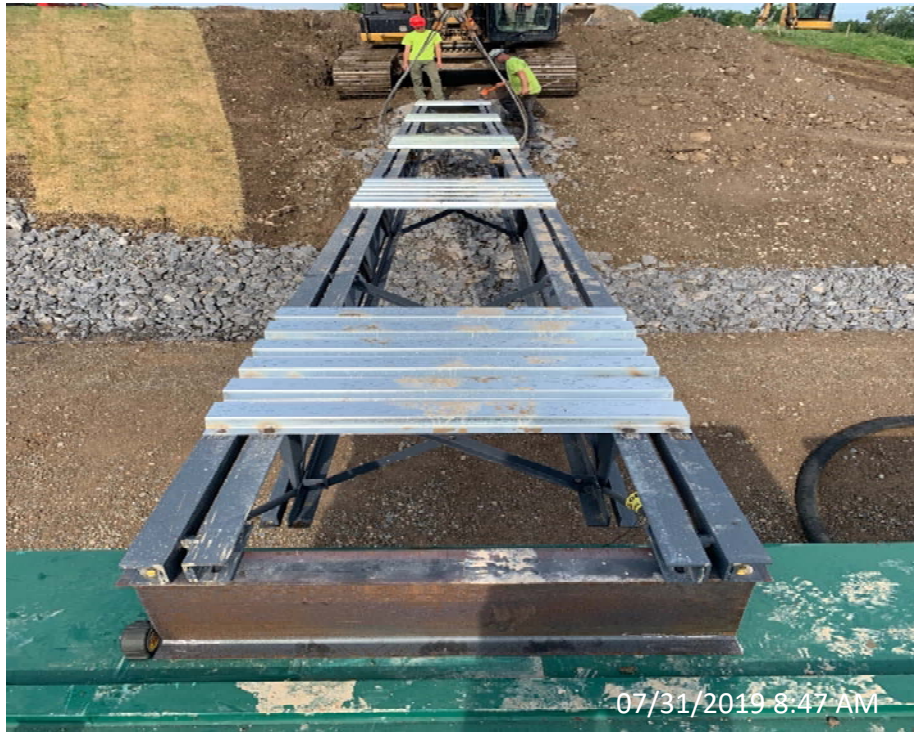
Photo 37- Placement of LSTA Pipe Bridge Looking West
