# **CERTIFICATION REPORT**

## **Settling Pond Sediment Removal and Improvements**

**LOCKWOOD ASH DISPOSAL SITE**

**December 2019**

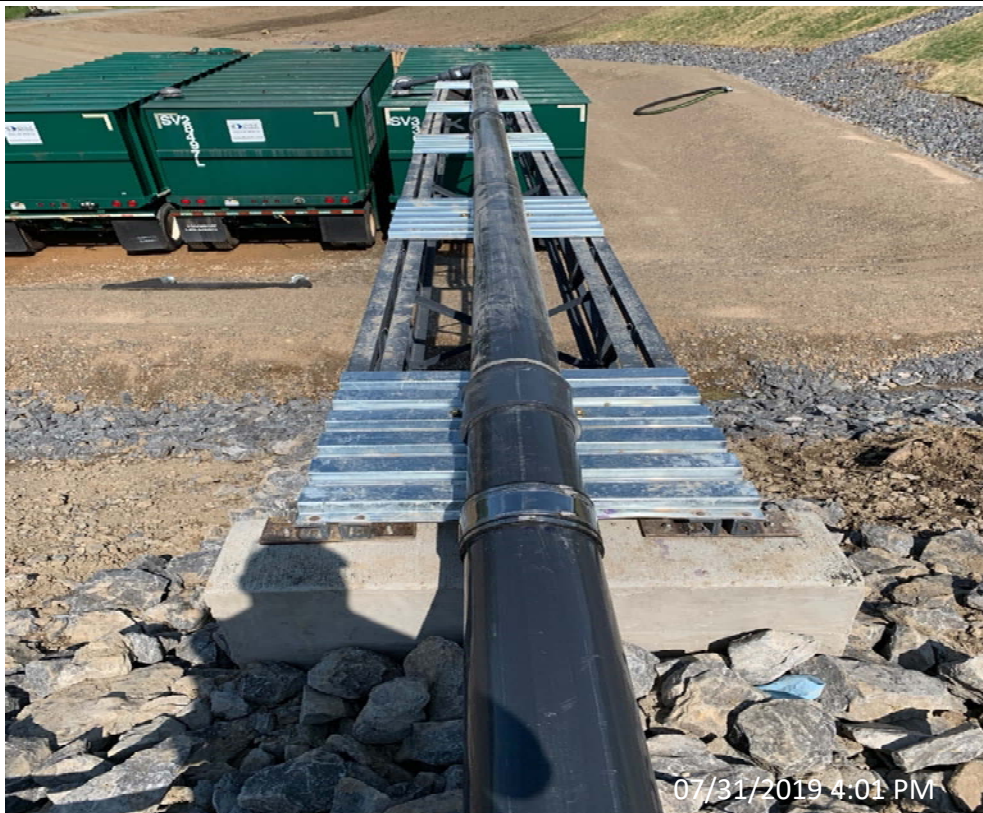
Photo 38- LSTA Pipe Brige Pipe Installation Looking East

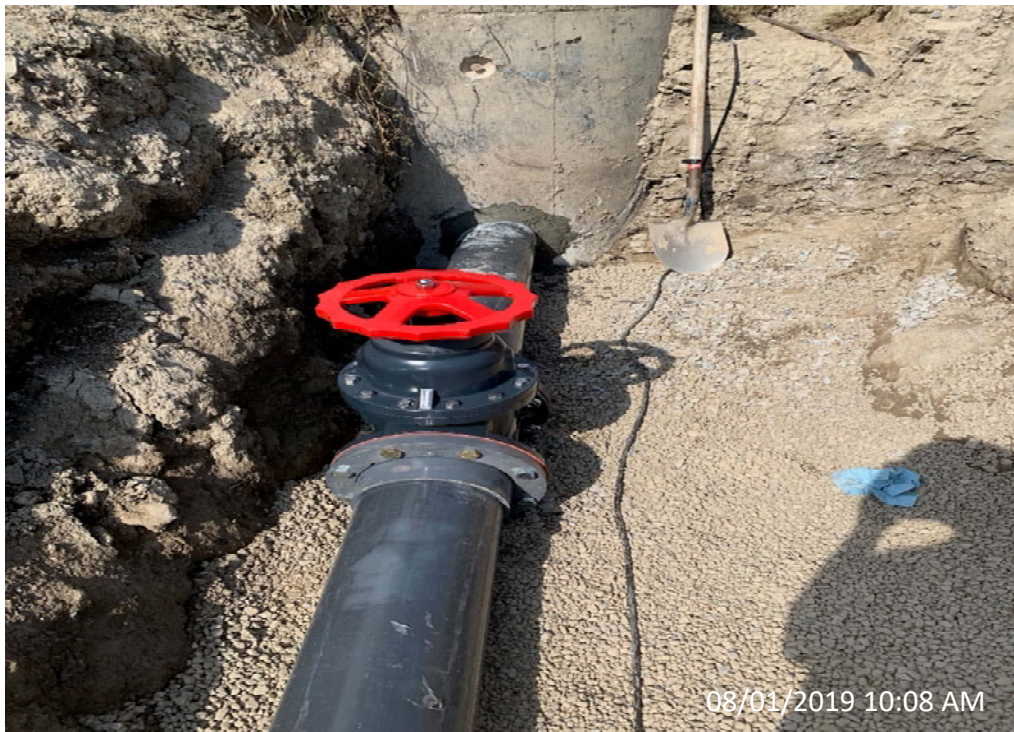
Photo 39- Gate Valve Installation at Manhole MH Common-1

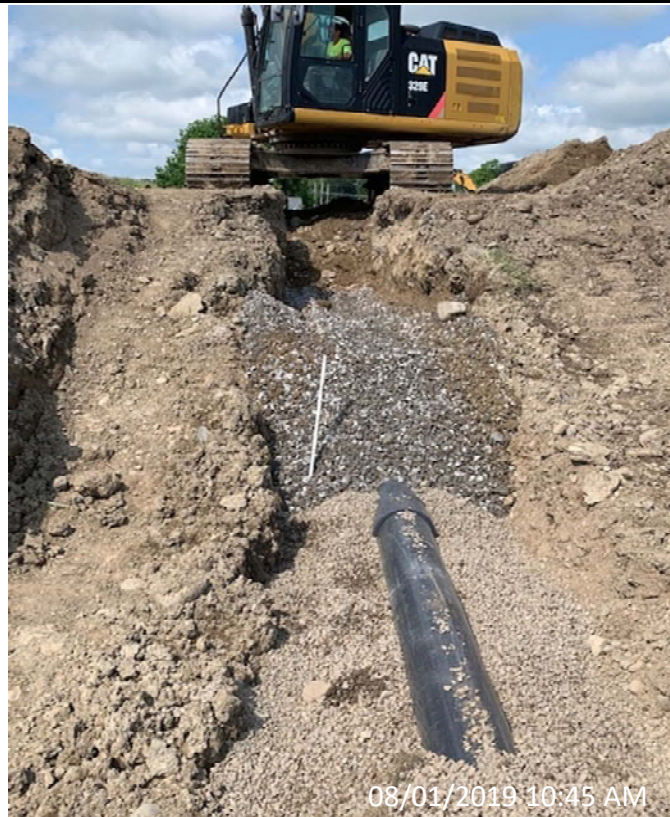
Photo 40- Leachate Sewer Pipe Installation

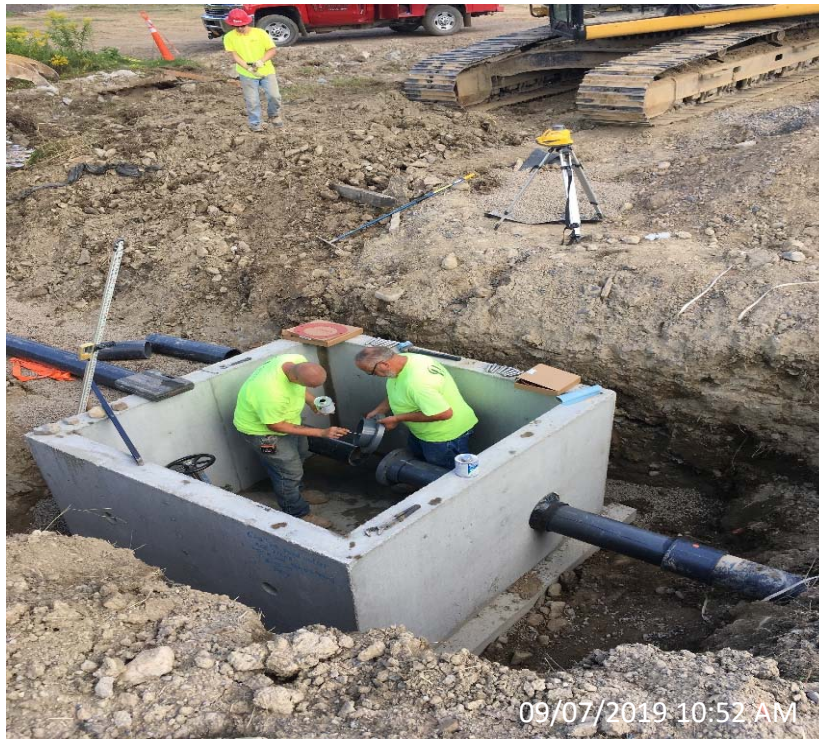
Photo 57- Settling Pond Outlet Gate Valve and Concrete Vault Installation

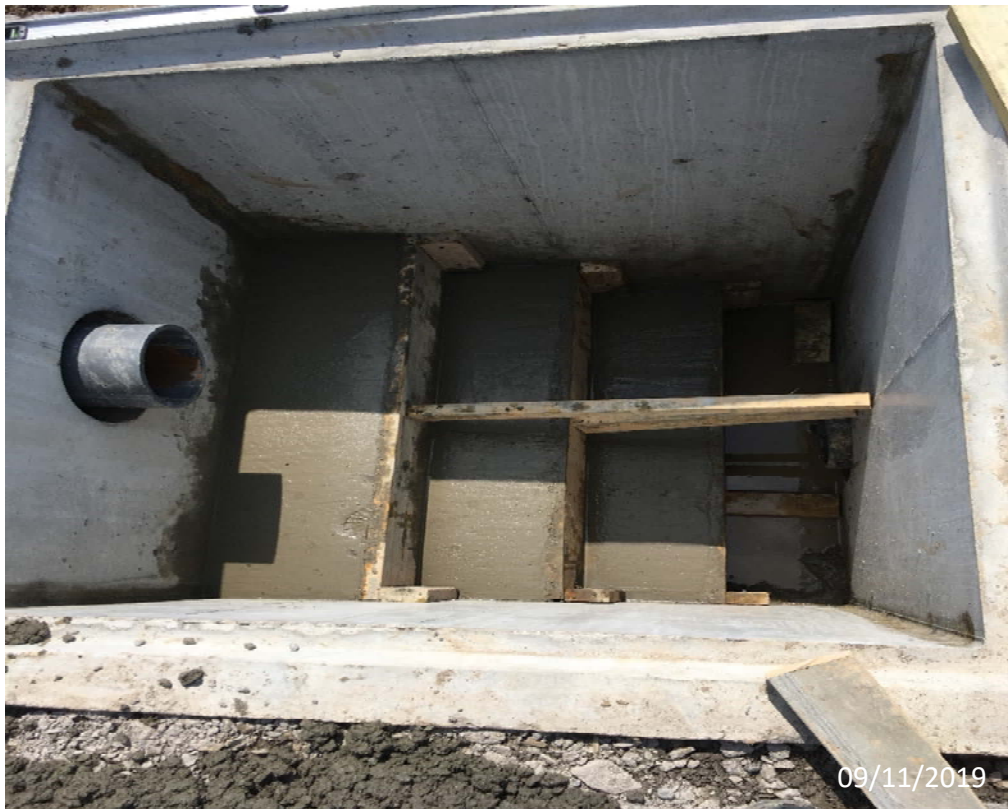
Photo 58- Settling Pond Cascade Aerator Concrete Steps Installation

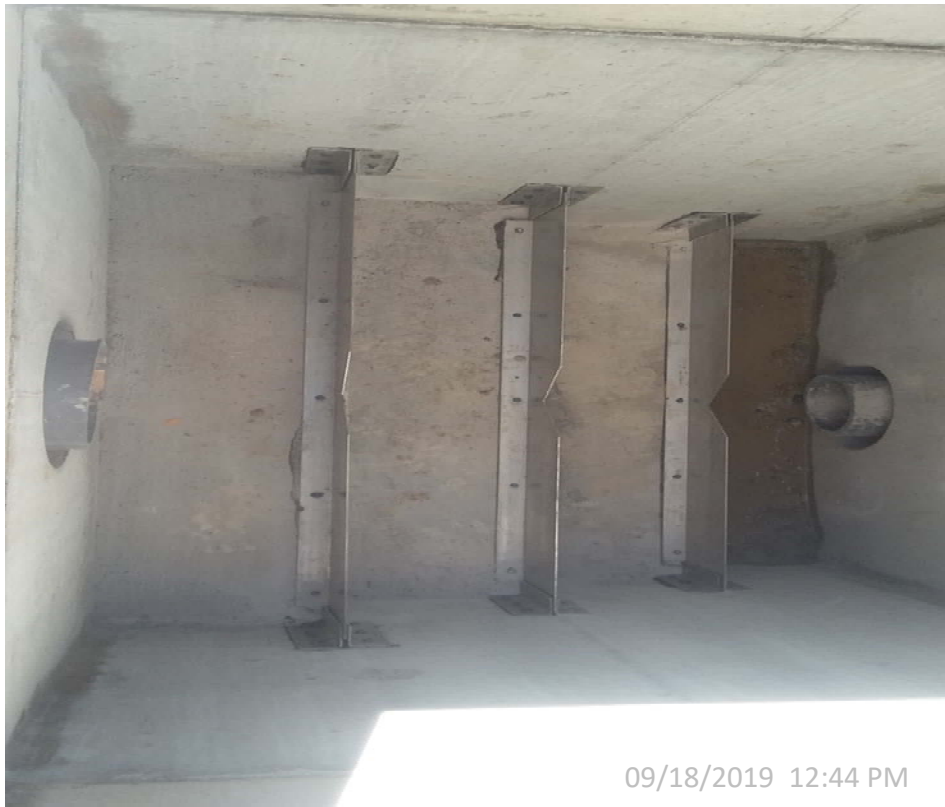
Photo 62- Settling Pond Cascade Aerator V-Notch Weirs

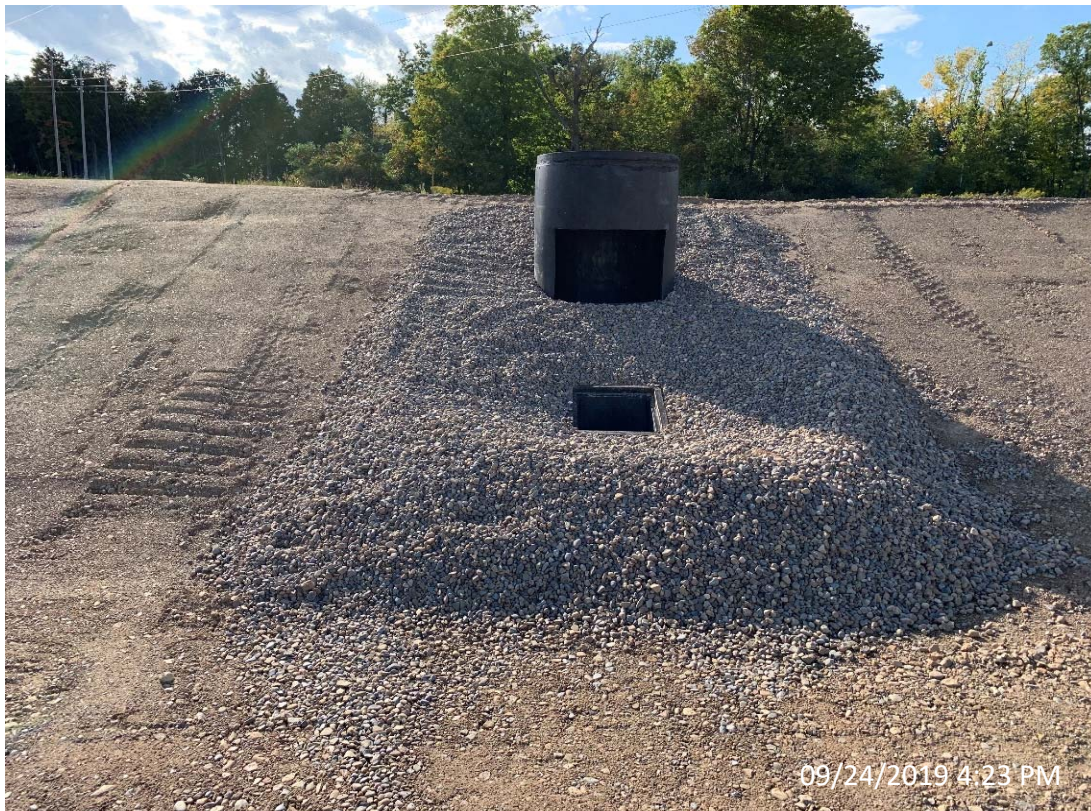
Photo 64- No. 2 Stone Placement Around Settling Pond HDPE Outlet Structures

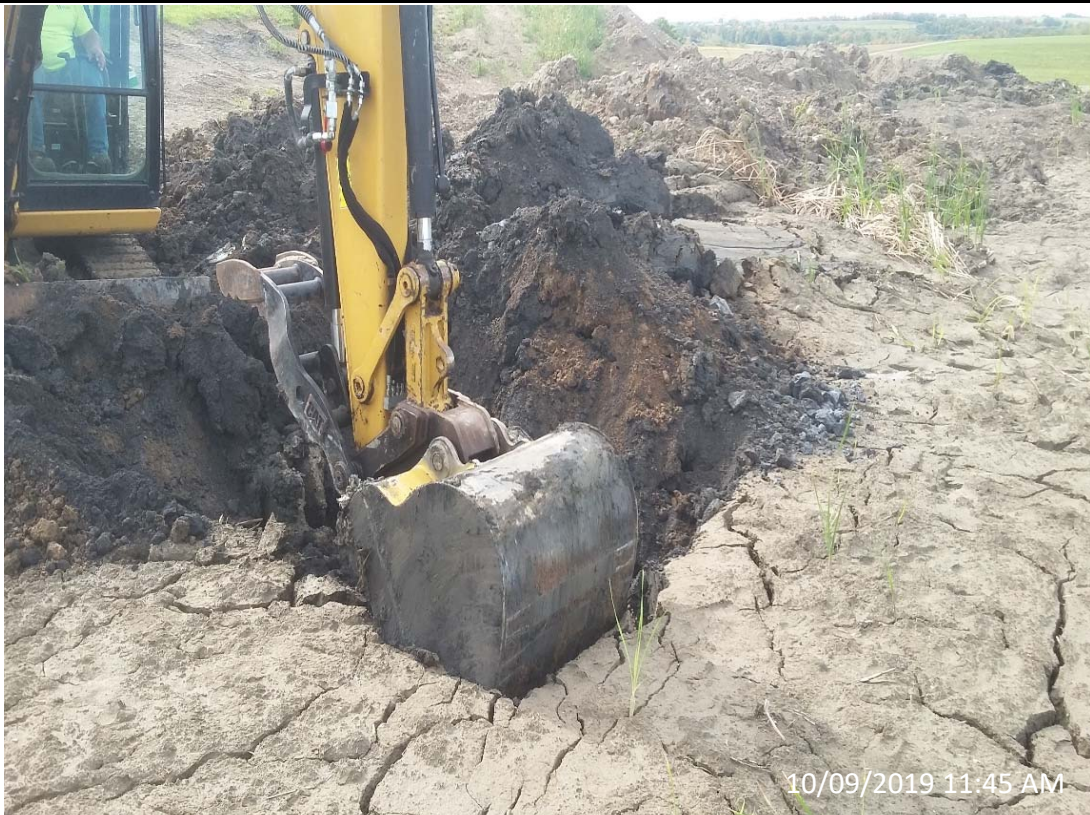
Photo 66- Sediment Mixing with Underlying Fly Ash in the Confined Disposal Area

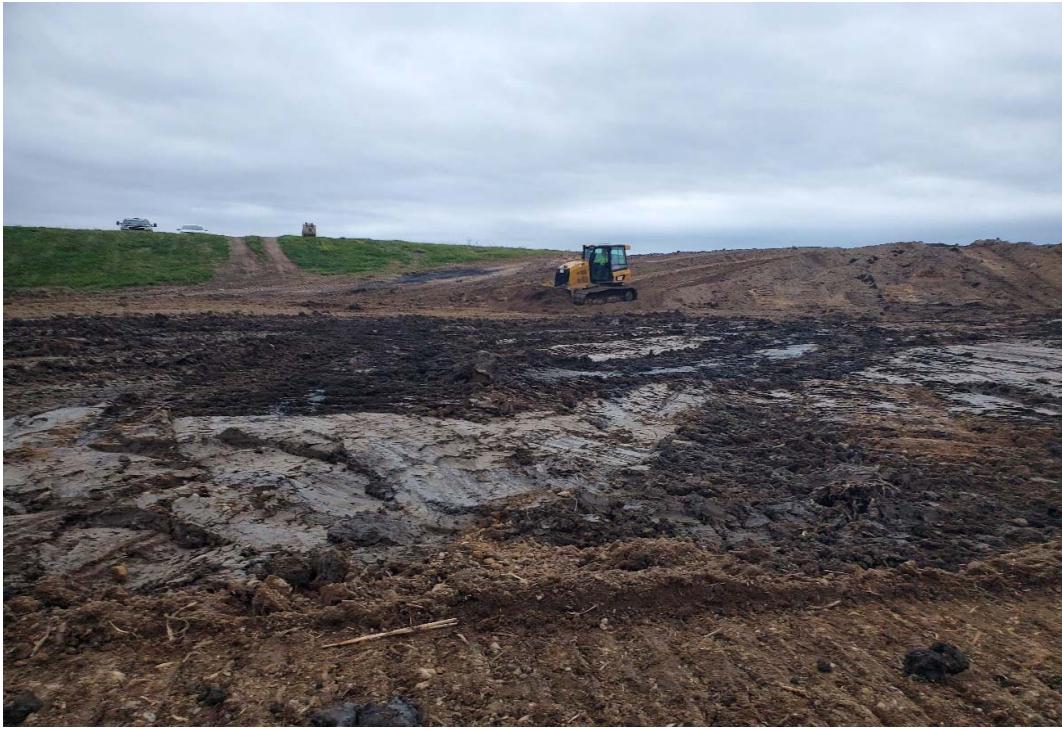
Photo 67- Sediment Stabilization and Grading Within the Confined Disposal Area
