# **CERTIFICATION REPORT**

## **Settling Pond Sediment Removal and Improvements**

**LOCKWOOD ASH DISPOSAL SITE**

**December 2019**

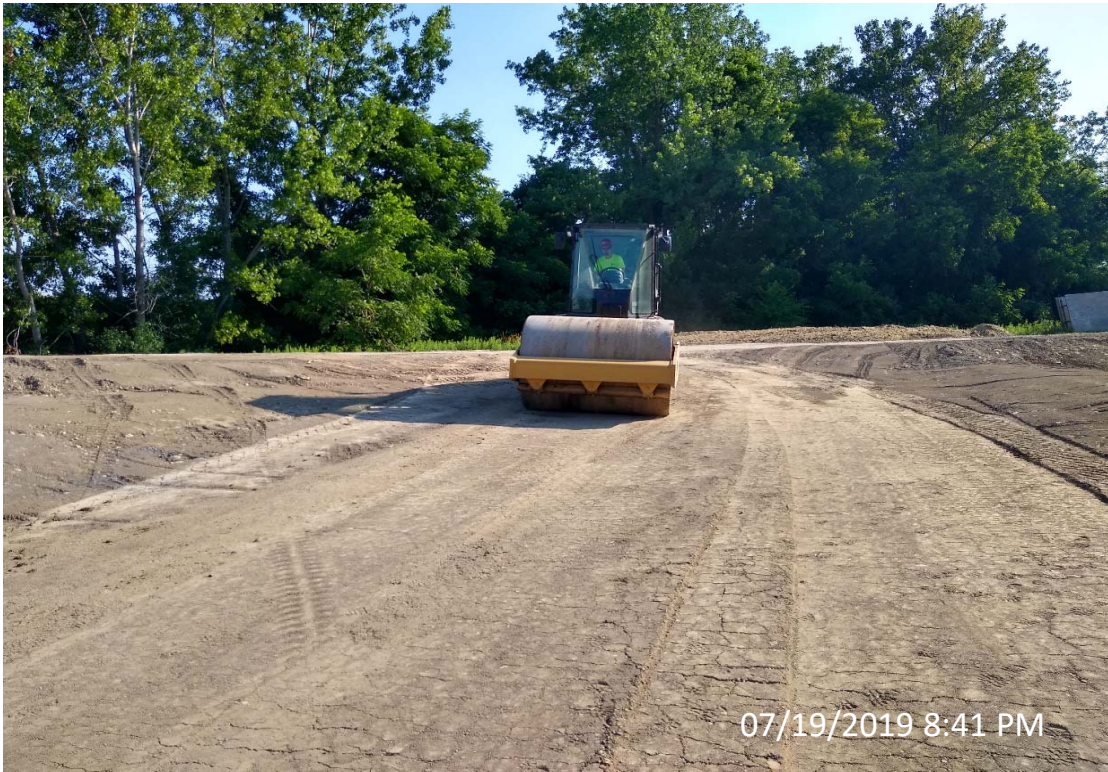
Photo 11 - LSTA Proofrolling Looking Northeast
